MISCELLANEOUS PAPER C-78-19

# GROUTING OF SCoured FOUNDATION OLD RIVER LOW SILL STRUCTURE, LOUISIANA

Hugh K. Wilson

December 1978

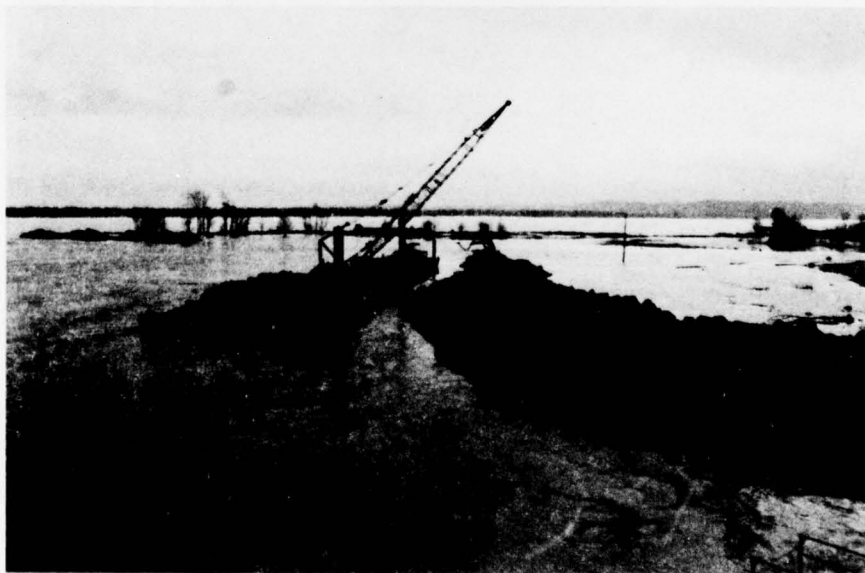
4. During the 1973 flood at Old River Low Sill Structure an eddy developed behind the southeast wing wall, and in April 1973 the major portion of this wing wall collapsed. Surveys of the forebay indicated a large scour hole, maximum depth -65 ft,\* had formed in front of gate bays 8-11. The immediate repair consisted of placing riprap in the scour hole in the forebay area and the construction of a rock dike to replace the collapsed wing wall (Figure 2).

Figure 2. Rock dike and remainder of collapsed wing wall (lower right)

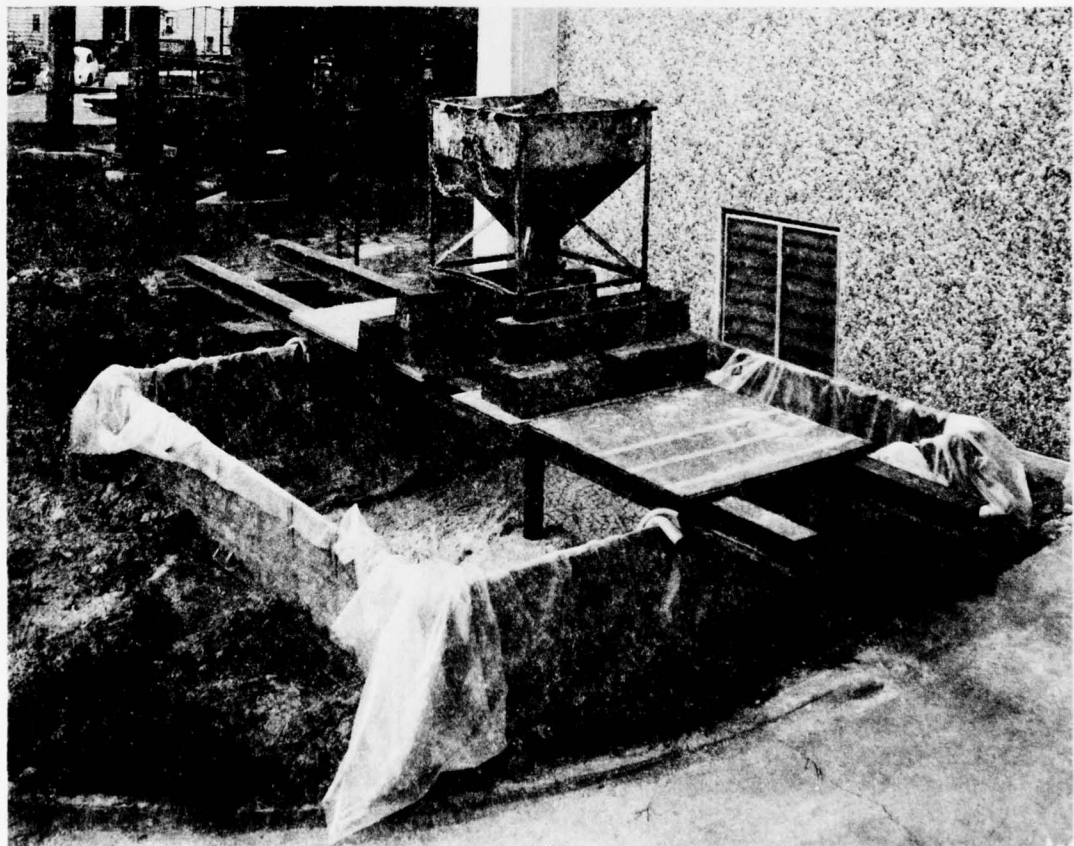
15. A laboratory-controlled, field-simulated test was conducted using a high-slump concrete and tremie in a water-filled sump (Figures 4 and 5). Several problems surfaced during this test: (a) the lack of self-leveling properties, (b) the possibility of the mixture segregating and diluting, and (c) the actual handling of such a long tremie led to the decision to use highly pumpable, self-leveling, sanded and nonsanded grout mixtures.

Figure 4. Field-simulated tremie placement test

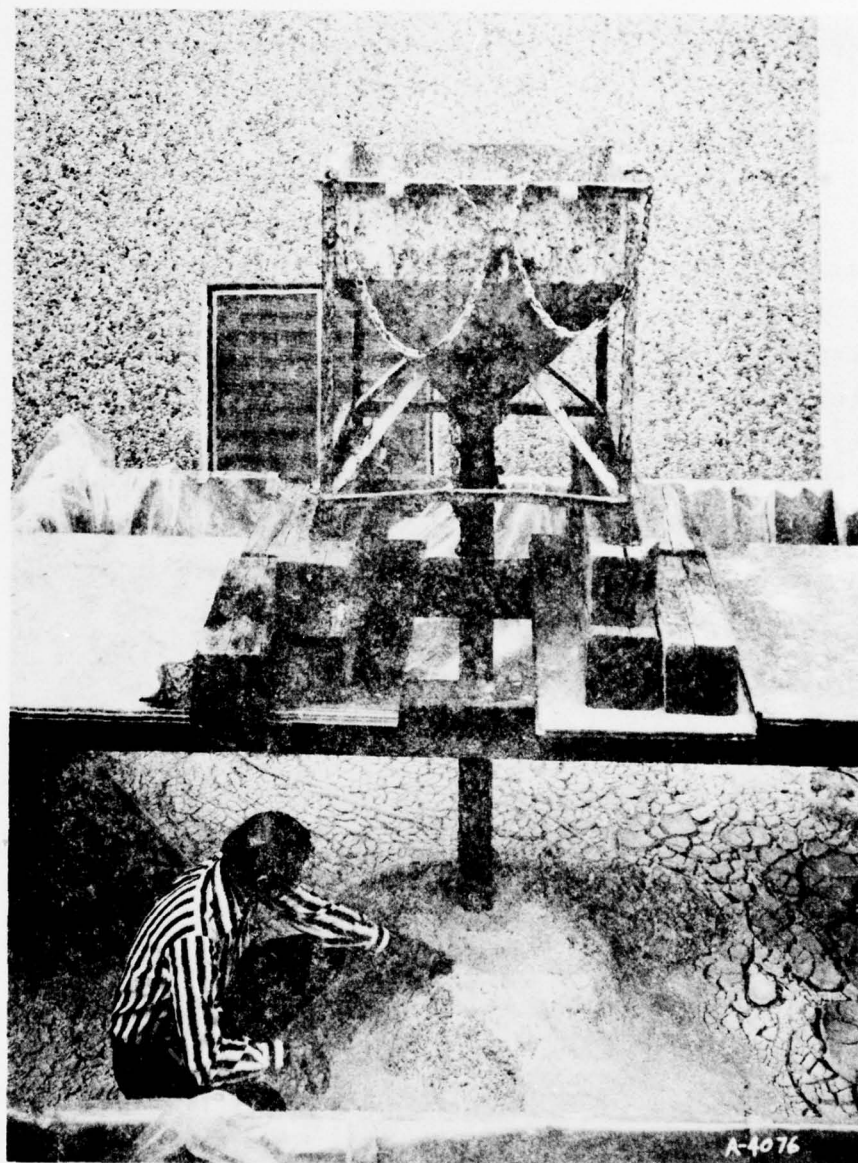
Figure 5. Close-up of tremie mixture showing lack of self-leveling properties and segregation and dilution

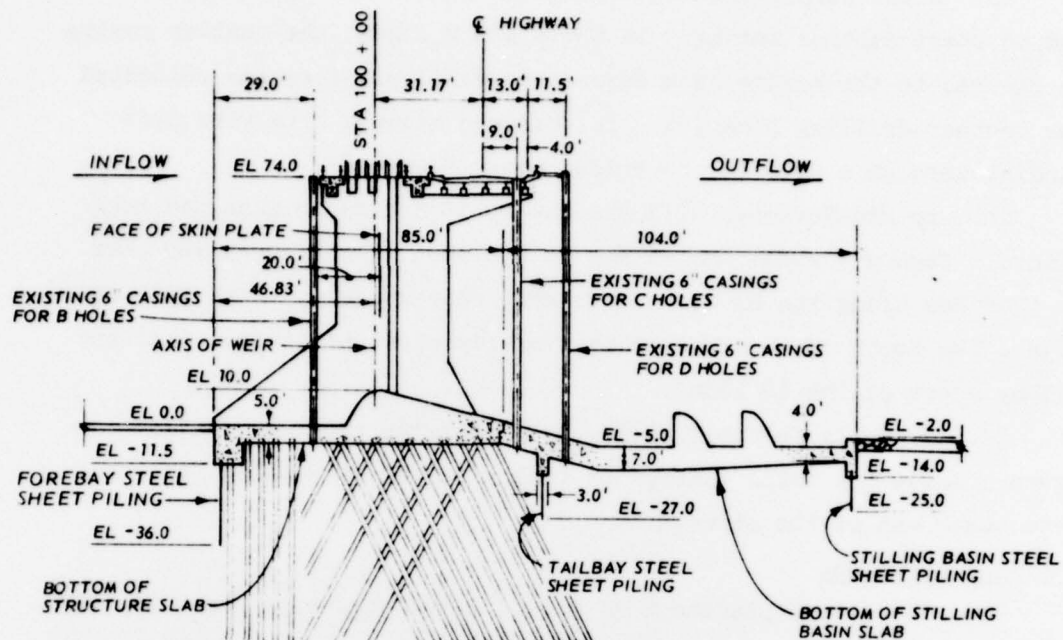
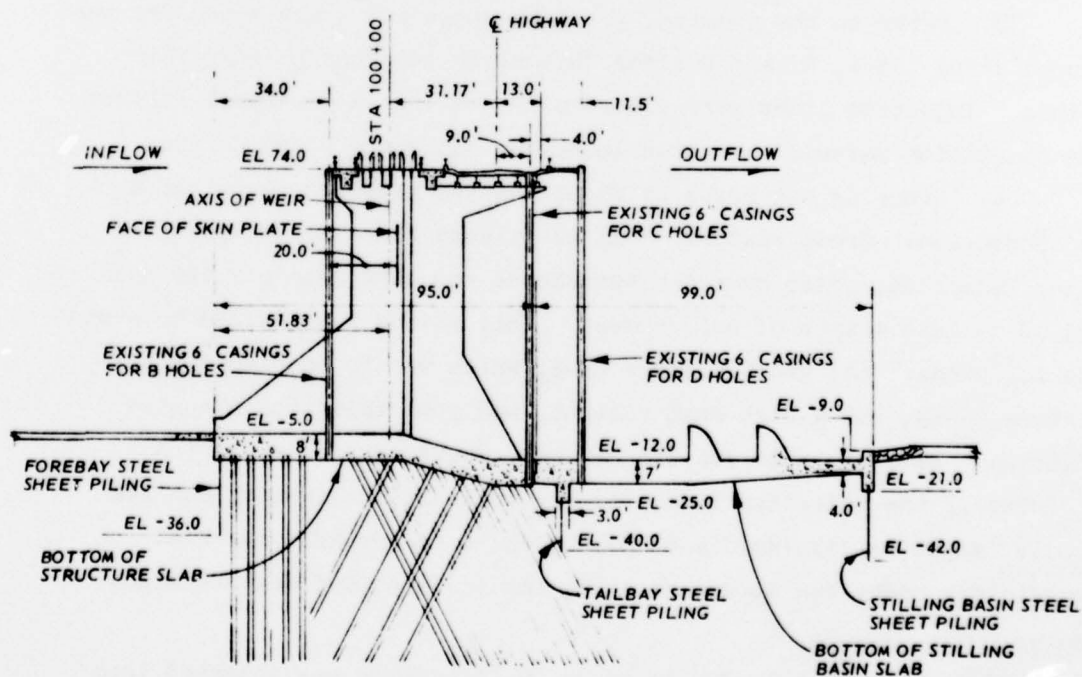
Figure 6. Profile of structure and locations of B-, C-, and D-line borings at gate bays 1-11

GATE BAYS 1-4 AND 8-11

GATE BAYS 5-7

19. After completing the boring the larger casing was pulled and used to start another boring. In the B and D lines, the smaller casing was secured to the bridge deck before the drill platform was relocated over another drilling location. The casings along C line were left standing through a hole in the bridge deck (Figure 6).

23. Prior to the pumping, pressure gages and grout detectors were placed along the B, C, and D lines in borings adjacent to injection points. Injection lines were placed with the discharge ends 1 ft from the foundation material at three locations along the B and C lines.

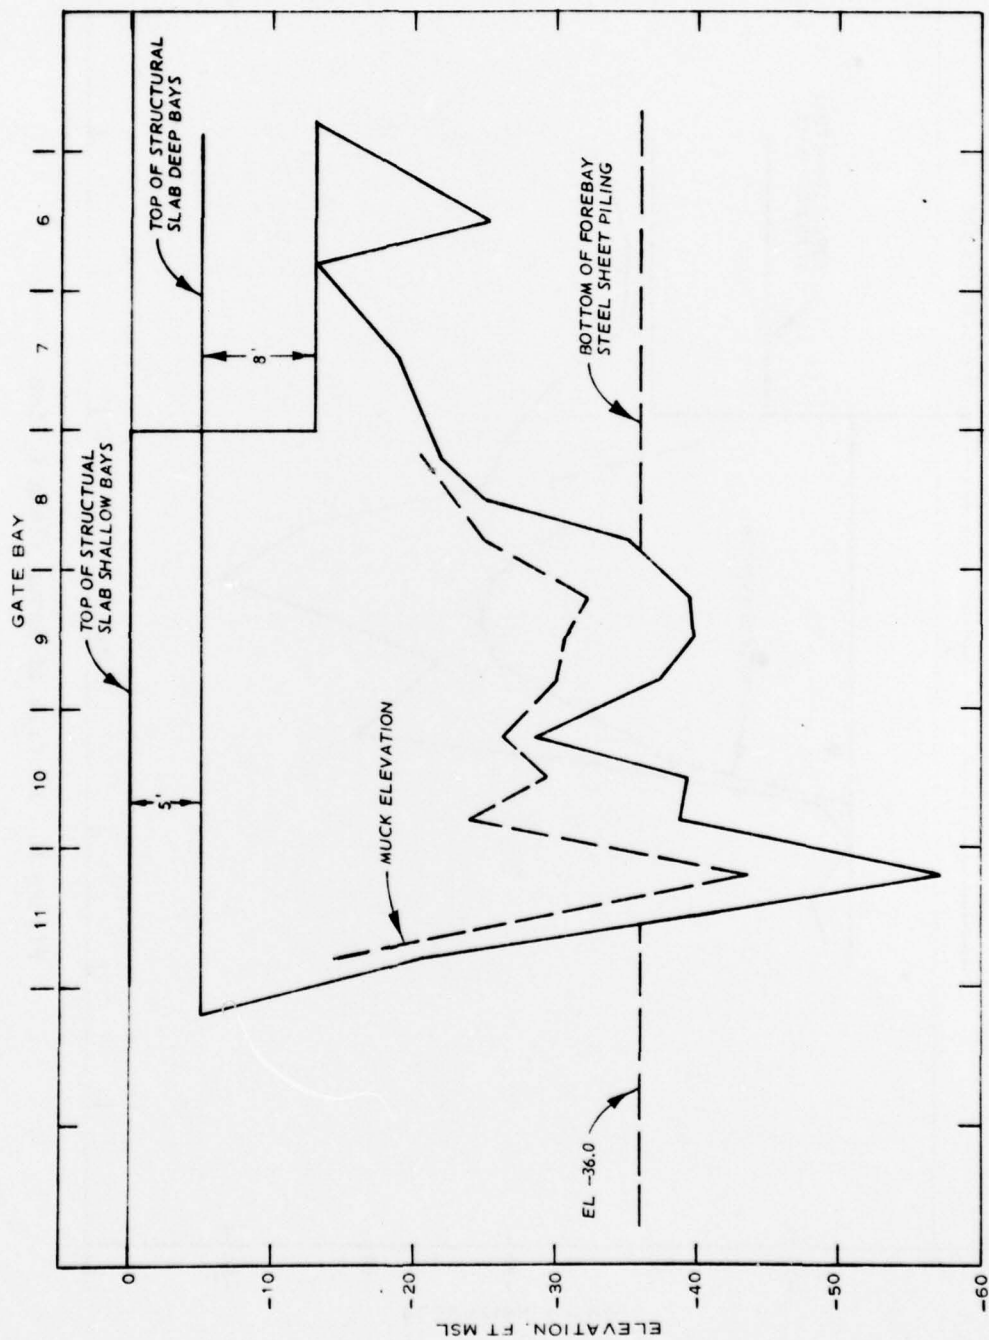
20. By mid-November 1973 the extent of the scour area had been defined. Figure 3 shows the extent of the scour and Figures 7-9 show the profiles along the B, C, and D lines, respectively. Note on B and D lines the depth of scour below the forebay sheet piling (B line) and tailbay sheet piling (D line).

Figure 7. Profile of scour area along B line

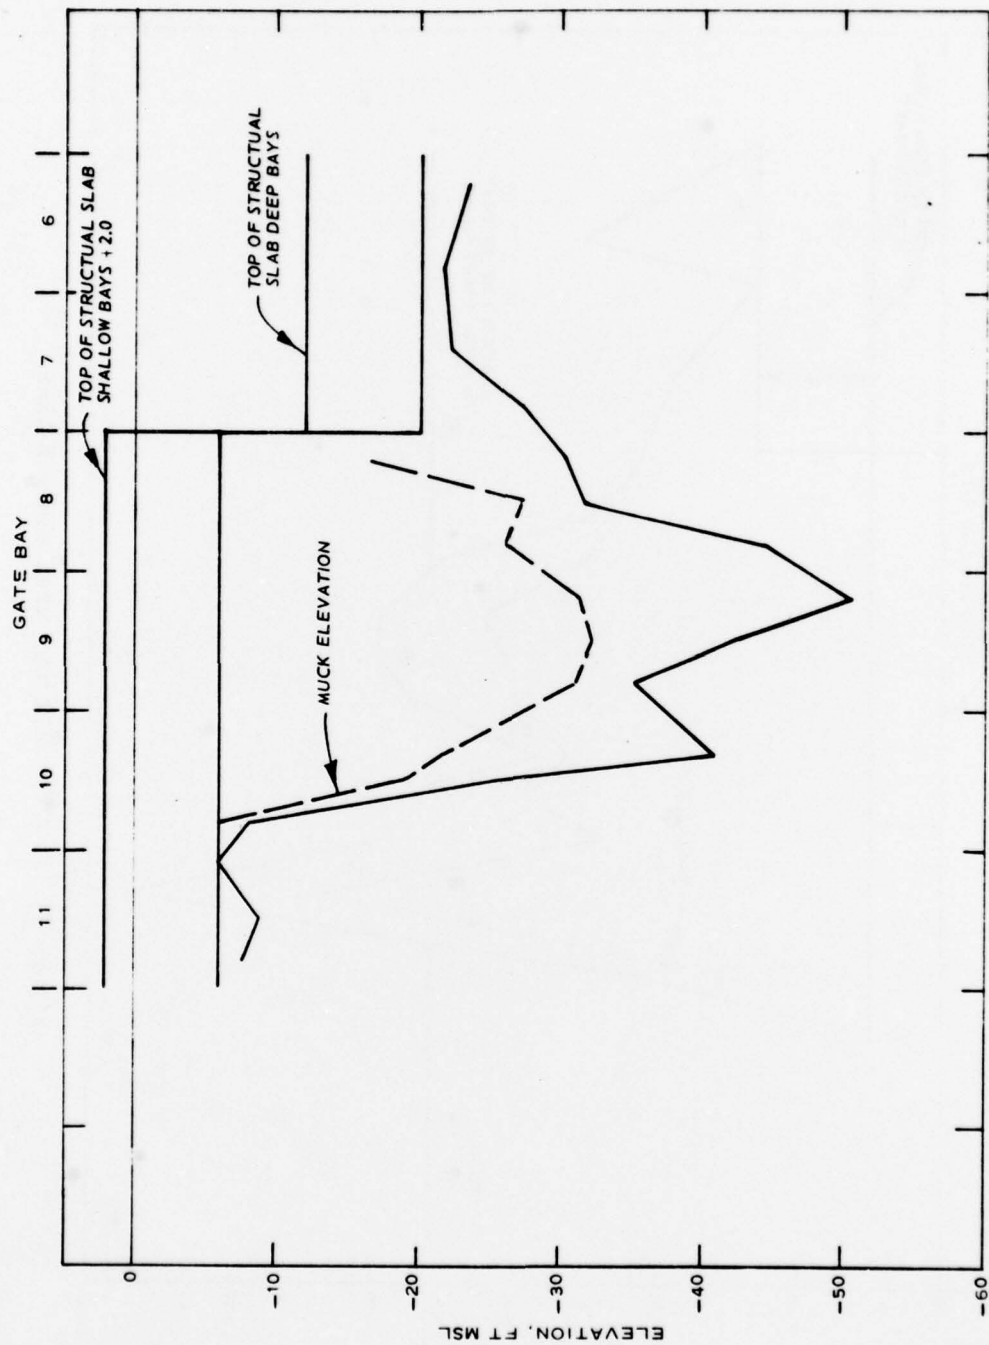
Figure 8. Profile of scour along C line

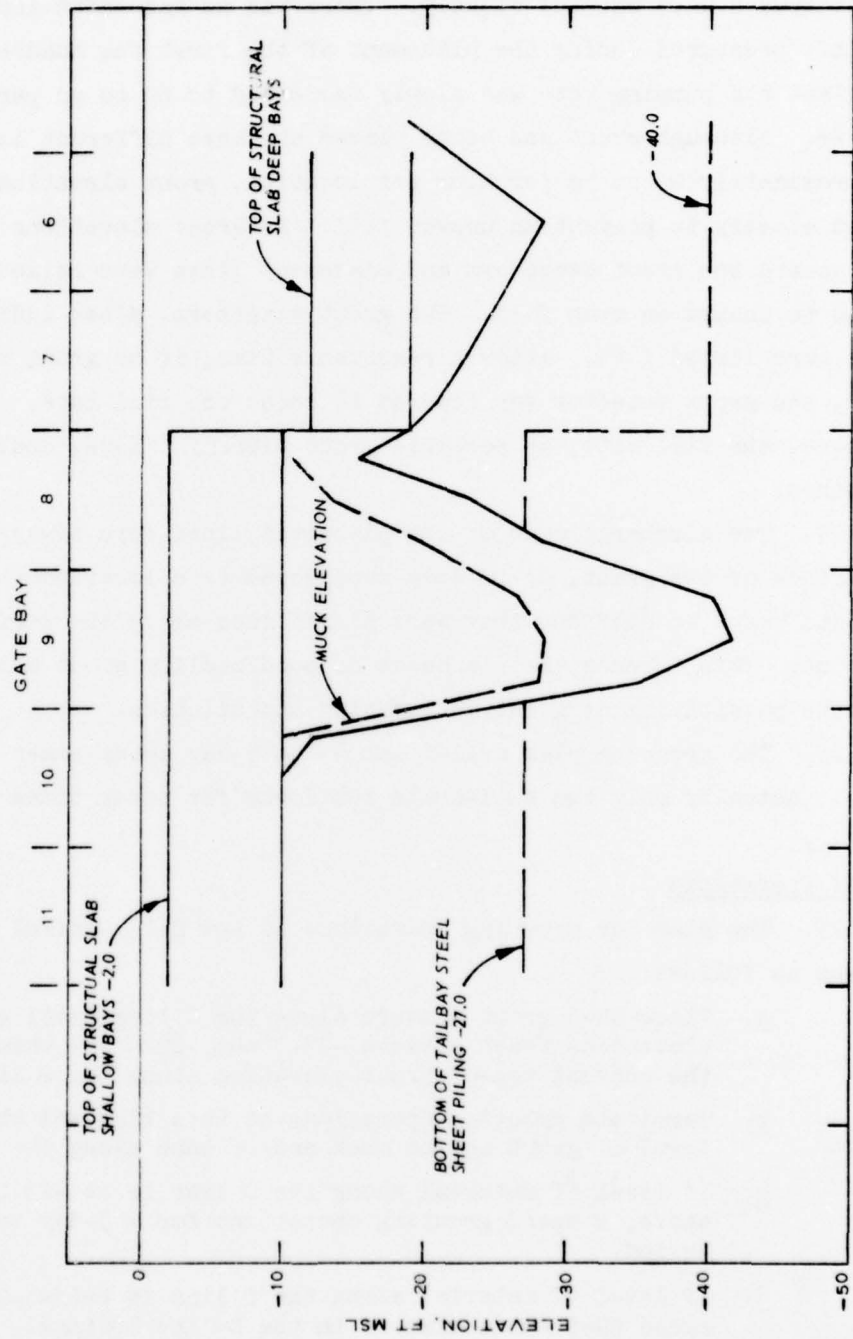
Figure 9. Profile of scour along D line

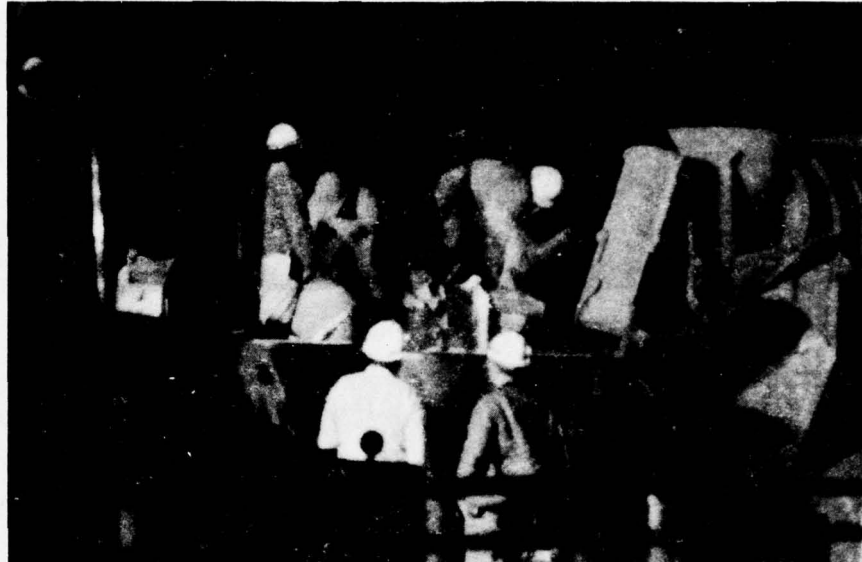
Figure 10. Mixing of IMCO flakes in blending pots
